**WASTE MATERIAL SAMPLING REPORT
NELLIE GRANT MINE
JEFFERSON COUNTY, MONTANA**

Mr. Stu Levit
Abandoned Mine Reclamation Bureau
Montana Department of State Lands
1625 Eleventh Avenue
Helena, Montana 59620

Chen-Northern, Inc.
P.O. Box 4699
Helena, Montana

October, 1990

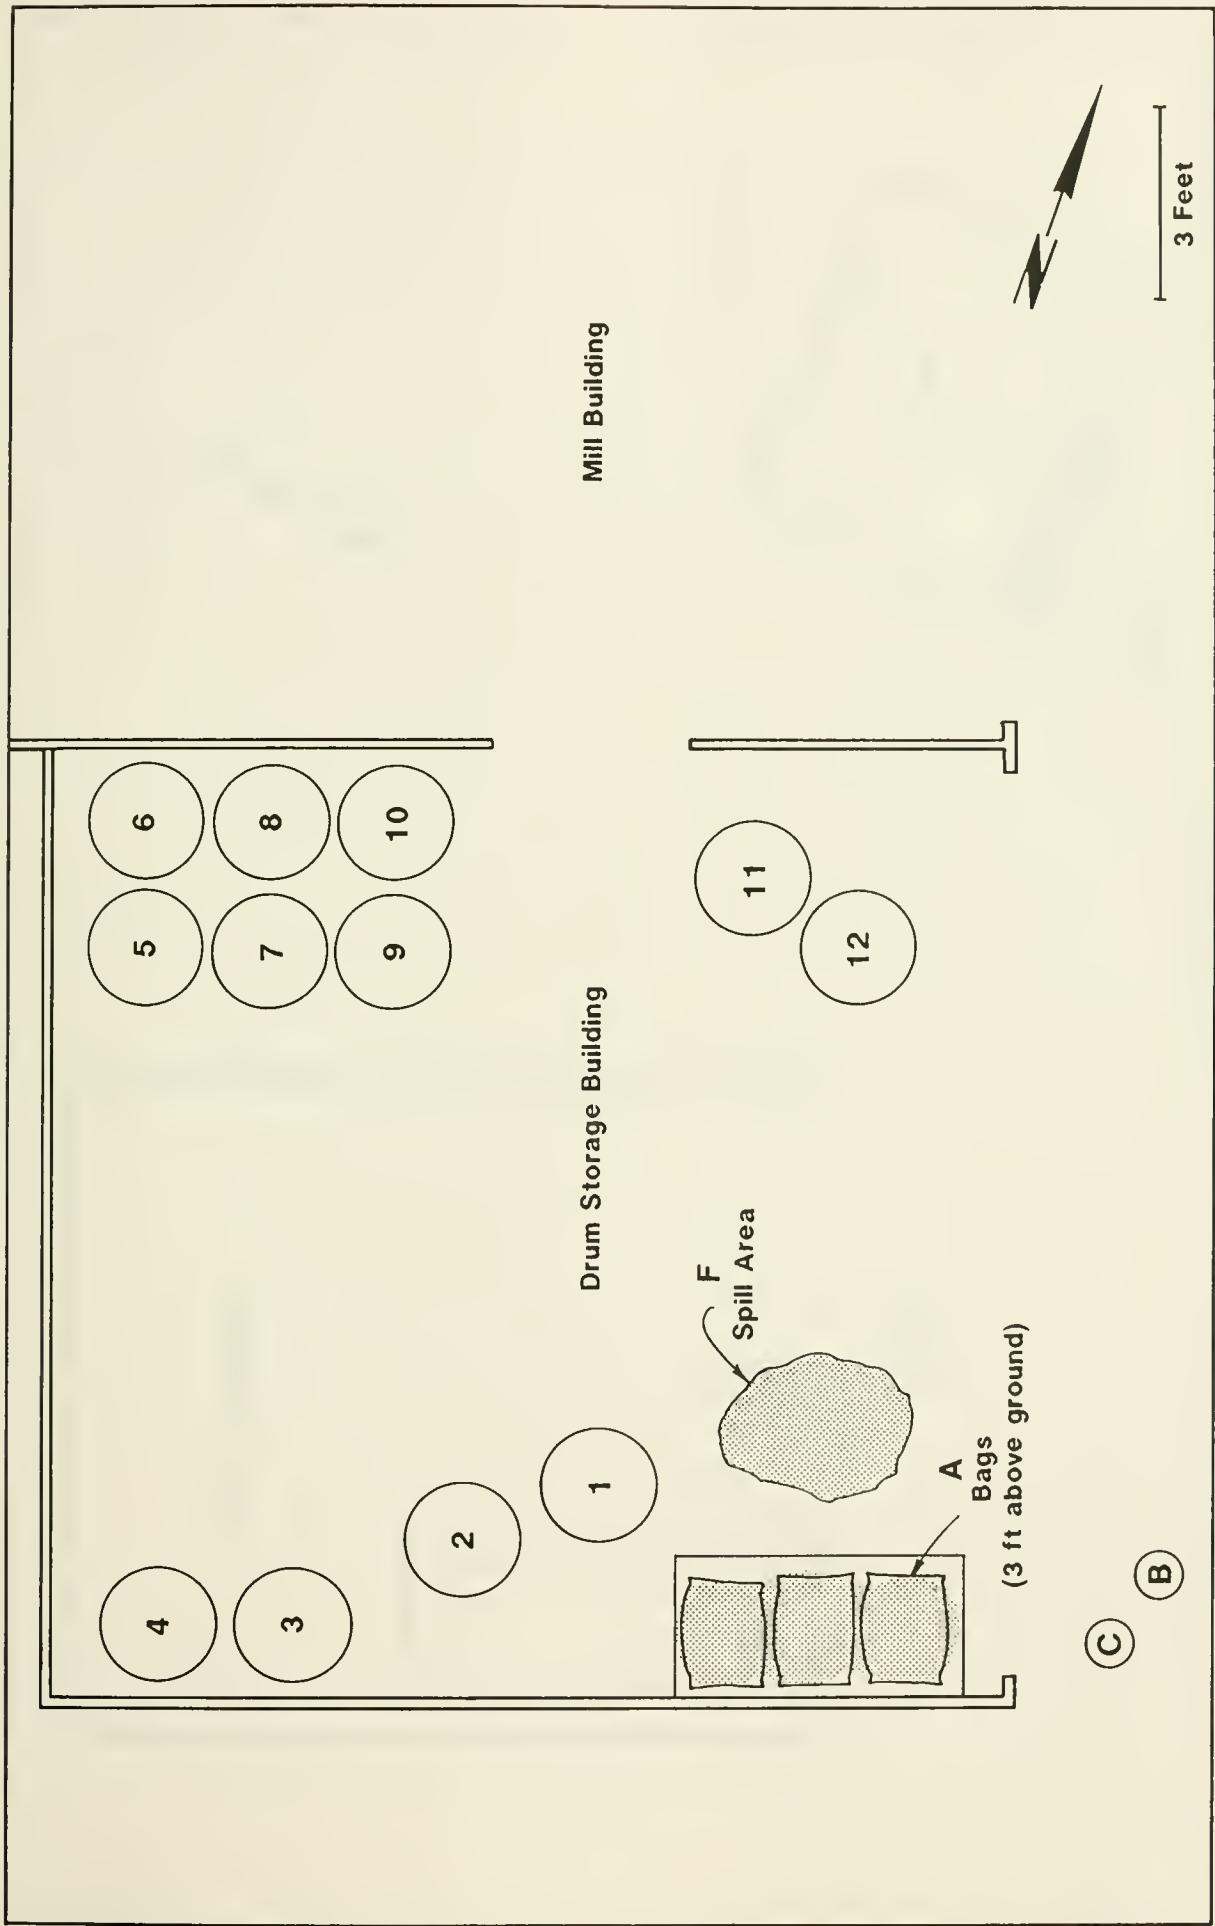
Sampling Stations
Drum Storage Building
Nellie Grant Mine, Jefferson County, Montana
FIGURE 2

- ♦ Waste container D (Figure 2) was not sampled because the container was apparently removed from the site sometime between the site reconnaissance visit and the sampling event; and
- ♦ Waste containers G (Figure 3) and sampling locations I and H (Figure 3) were added to the sample train to complete waste material characterization at the site.
